**Region 9 Enforcement Division
75 Hawthorne Street
San Francisco, CA 94105**

Inspection Date(s):	August 21, 2019		
Time:	Entry: 9:00 am	Exit: 10:30 am	
Media:	Water		
Regulatory Program(s)	Clean Water Act NPDES		
Company Name:	Dos Cuadras Offshore Resources, LLC (DCOR)		
Facility or Site Name:	Platform Habitat		
Facility/Site Physical Location:	Platform Habitat, Santa Barbara Channel, Pacific Ocean Lease OCS-P-0234		
Geographic Coordinates:	34°17'12.31"N, 119°35'19.23"W		
Mailing address:	290 Maple Court, Suite 290 Ventura, CA 93003		
Facility/Site Contact:	Jay Rao	Title: Environmental Engineer	
	Phone: 805-535-2078	Email: jrao@dcorllc.com	
Facility/Site Identifier:	NPDES Permits CAG280000 and CAF001304		
NAICS:	211111 - Crude petroleum and natural gas extraction		
SIC:	1311		
Facility/Site Personnel Participating in Inspection:			
Name	Affiliation	Title	Email
Jay Rao	DCOR	Environmental Engineer	jrao@dcorllc.com
Jacob Ruth	DCOR	Lead Operator	habitatuser@dcorllc.com
EPA Inspector(s):

SECTION I – INTRODUCTION

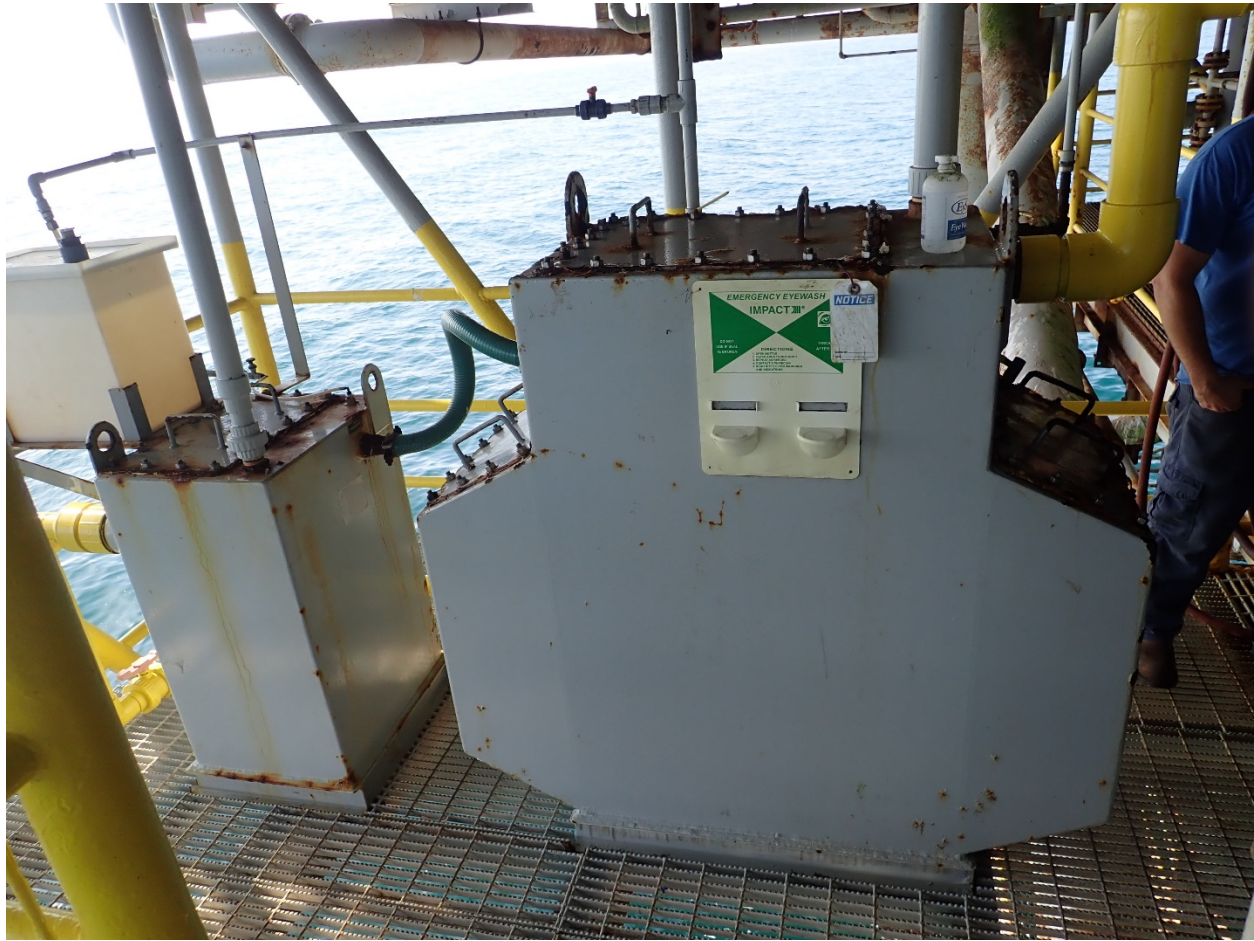
Sanitary Wastewater (Discharge 005) is treated onsite at the Facility with a redFox environmental marine sanitation device (MSD) which is United States Coast Guard (USCG) approved (Photograph 1). The treated water is discharged (Discharge 005) to the Pacific Ocean via a pipe (Photograph 2). The onsite Facility representatives stated that the daily discharge water flow rate is estimated based on the number of people on the platform and the time spent per person. The MSD unit is sized for a maximum of 500 gallons per day (gpd).

Sanitary wastewater (Discharge 005) is ~~not~~ treated onsite at the Facility. Discharge 005 is treated via a redFox MSD (Photograph 1). The self-contained treatment system is composed of an aeration chamber, flocculation, solids settling, media filtration, and disinfection. The Platform chlorinates the treated effluent and checks the chlorine residual daily. The MSD is serviced annually by a contractor. The MSD was shutdown from January 2019 – June 2019 when the platform was unoccupied.

Photograph 1: RedFox Marine Sanitation Device

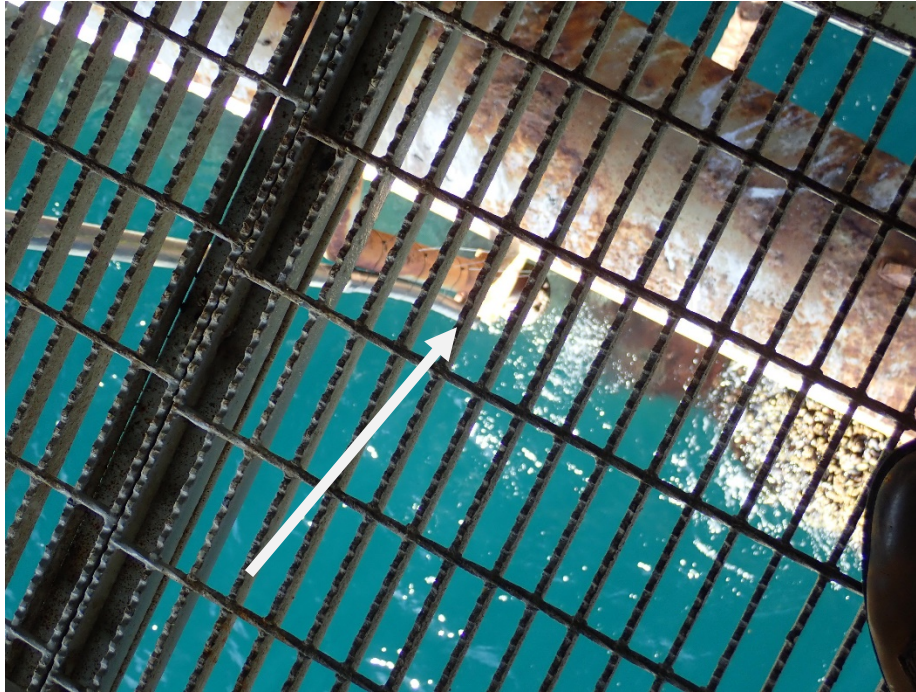
Photograph 2: Marine Sanitation Device discharge location.

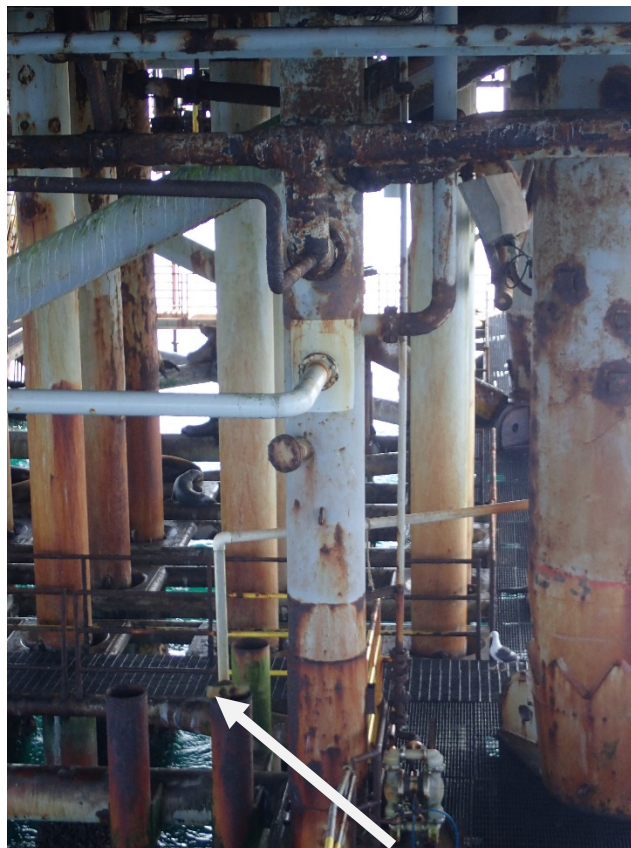
Desalination (i.e., reverse osmosis) unit wastewater (Discharge 007) is generated during the process of creating freshwater from saltwater. According to onsite Facility representatives, the desalination unit was not working at the time of the inspection. A new unit was to be installed soon and will only provide water to sinks and showers at the Facility. RO reject water will be discharged to the Pacific Ocean via a pipe (Photograph 3).

Photograph 3: RO Reject water discharge pipe

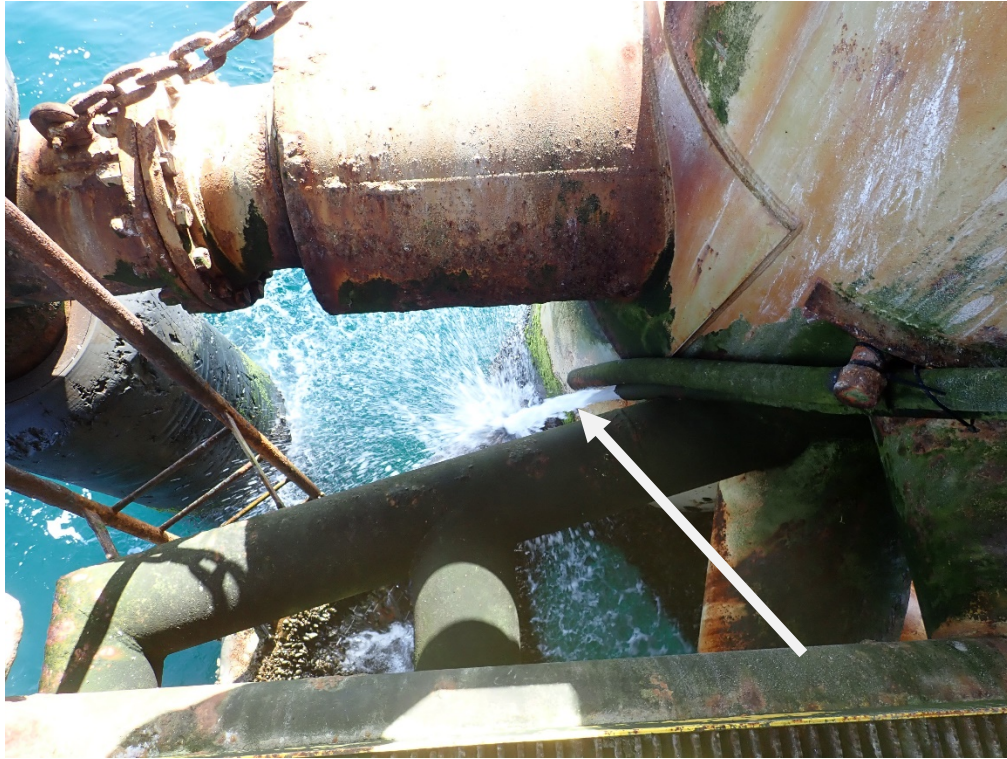
Fire control system water (seawater released during training, testing, and maintenance of fire protection equipment – Discharge 008) is composed of pure seawater that is constantly circulating throughout the Platform. The Fire control water is discharged through the pipes in (Photograph 4) without treatment.

Photograph 4: Fire water discharge.

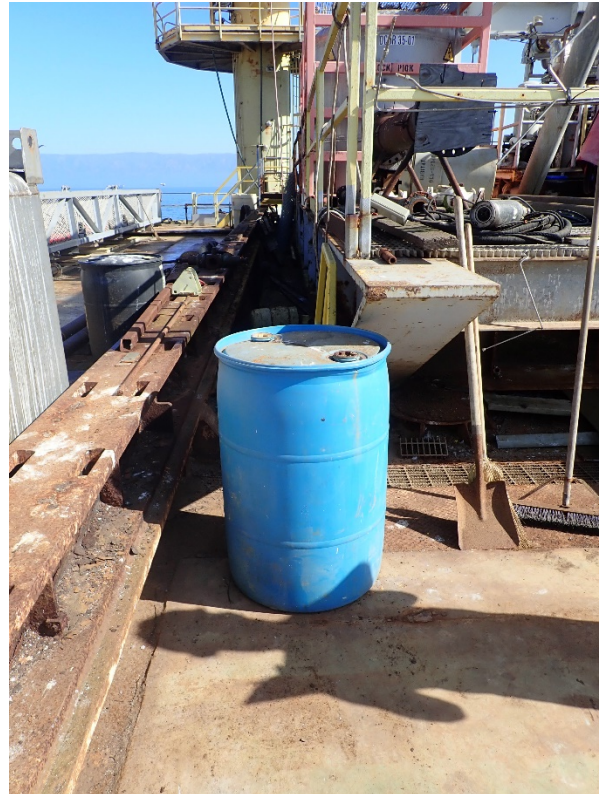
- During the Facility walk through, we observed one unlabeled 55-gallon drum (Photograph 5) on the Drill Deck and two unlabeled 55-gallon drums (Photographs 6 & 7) on the production deck. Mr. Ruth stated that samples from two of these drums were at the lab awaiting analyses to determine proper disposal methods. He told us the remaining drum was to be sampled for analysis in the near future.
- The NPDES permit, daily reports, and DMRs were all well organized and readily available on an electronic share drive accessible on the Platform.
- The platform had significant rust and corrosion and in places the floors seemed unsound.

Photograph 5 : Unlabeled drum on drill deck.

1. While a certain amount of rust and corrosion is to be expected in a harsh marine environment, the Facility should ensure that the corrosion does not negatively impact that operations or safety of the Platform or its ability to comply with the Clean Water Act.
2. The Facility needs to follow through on proper disposal of unlabeled chemicals.

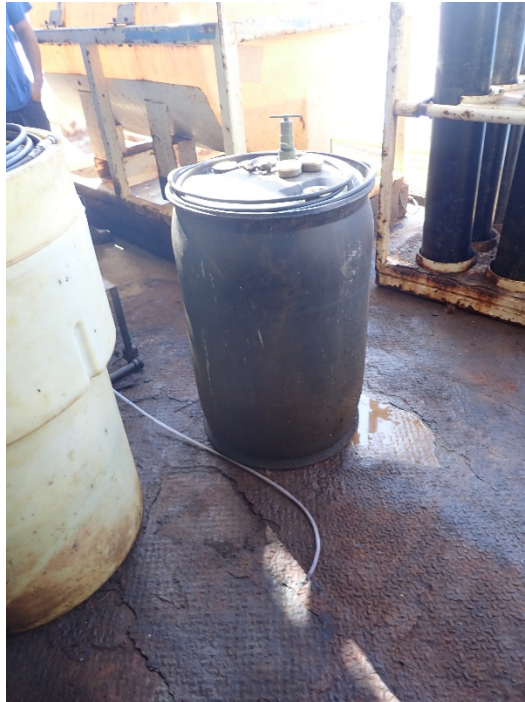
Photograph 6 : Unlabeled drum on production deck.

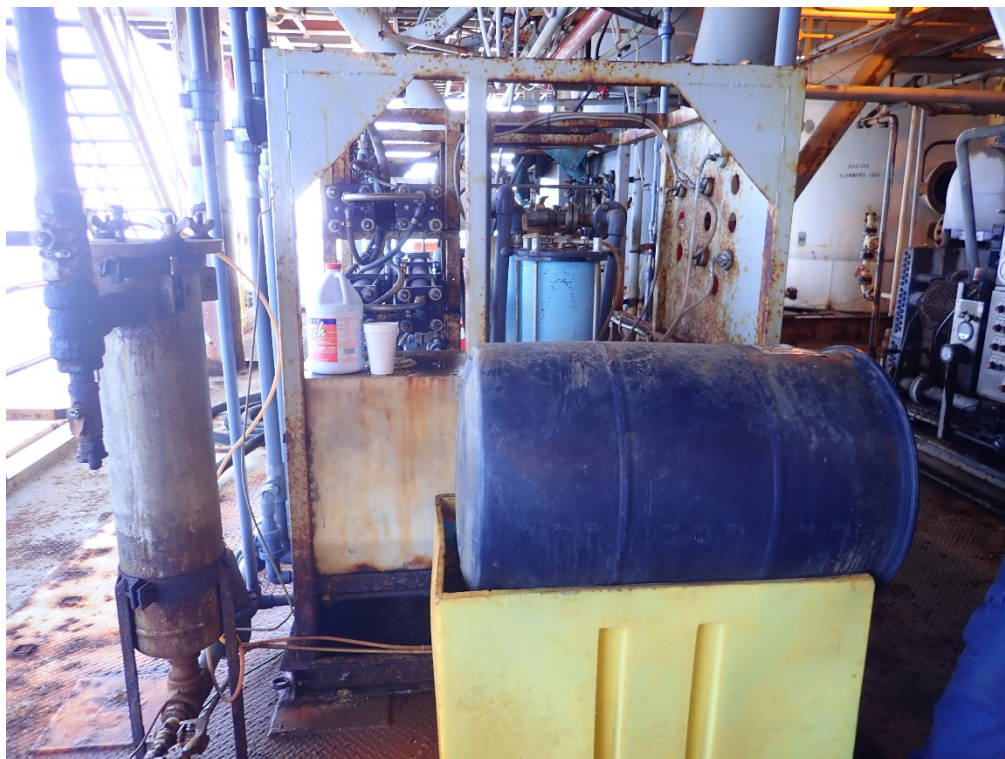
Photograph 7: Unlabeled drum on production deck.
